AIRCRAFT ACCIDENT INVESTIGATION

**MH-53M, S/N 69-05794
HURLBURT FIELD, FLORIDA
7 SEPTEMBER 2007**

**SUMMARY OF FACTS AND STATEMENT OF OPINION
MH-53M S/N 69-05794 ACCIDENT
7 SEPTEMBER 2007**

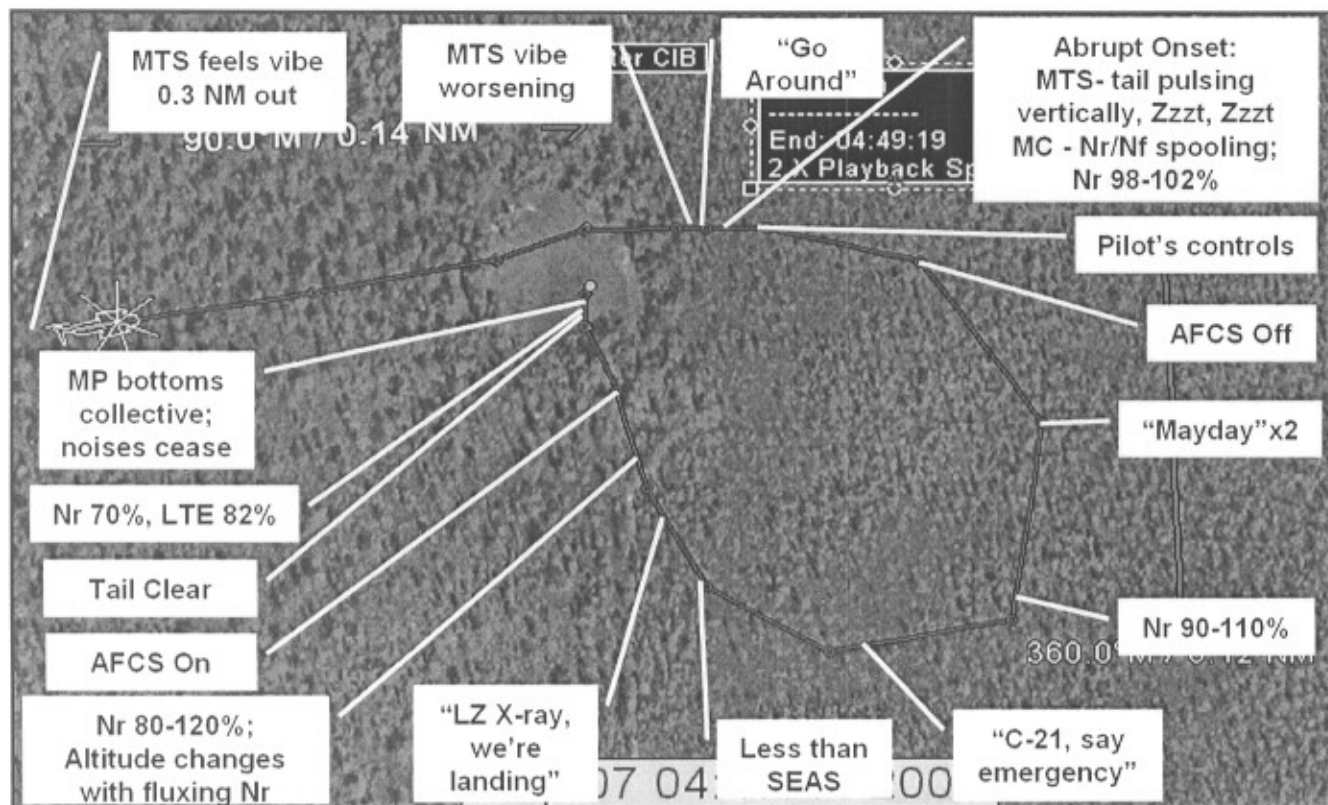
Figure 1 - MA ground track (based on mission computer data) and sequence of events (based on testimony and ATC data)

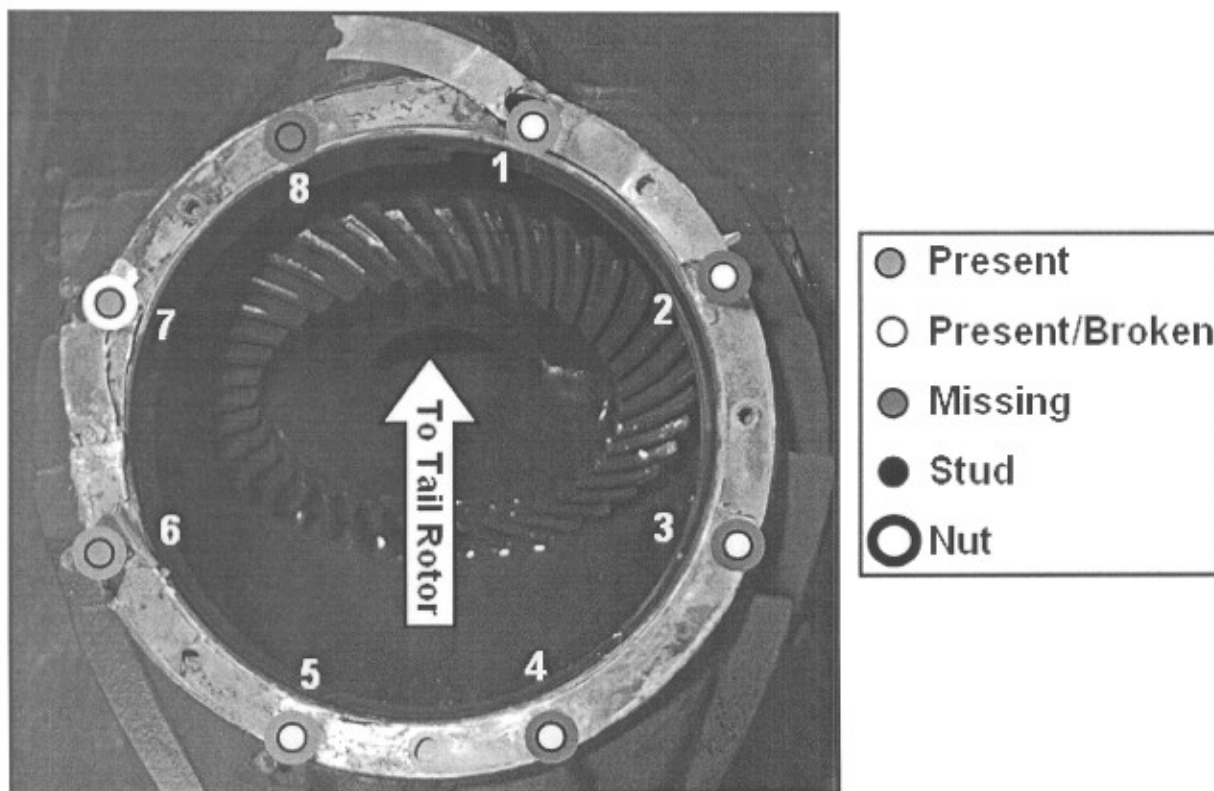
The intermediate gear box (IGB) was still attached and in its original position. However, it was loose in its mount and there was damage to the mounting studs, the gear box casing, and all the internal gear teeth (Tab J-9-11).

The IGB center housing was separated at the input housing casing mating surface. Eight mounting studs normally hold the input housing to the center housing. Visual inspection revealed one stud intact with a nut installed. The other seven mounting studs exhibited stripped threads, broken stud, stud pulled from their mounting holes, or a combination thereof. (See Figure 2 for positional reference on mounting studs and nuts.) Additionally, there were cracks found at the mounting stud holes at the #1 and #5 positions. The studs had been pulled from the mounting holes at these positions (Tab J-11). The final assessment indicated the housing had cracked and separated prior to removal of the #1 stud (Tab U-11.1). However, the threads in the #5 stud hole were stripped in the housing where the stud had pulled partially out (Tab U-11.1). The IGB mounting studs are attached to the center casing using a threaded insert drilled into the casing itself. The studs are then screwed into this insert, and the IGB is mounted to the aircraft and secured by nuts on the mounting studs. Additionally, assessment of the input and output gear heads on the IGB revealed impact damage to both gear assemblies. The IGB output shaft gear assembly was noted to have intermittent impact damage around the circumference of the assembly. NDI inspection revealed cracks over 75% of the gear tooth root area (Tab U-4.2).

Figure 2 - IGB Center Housing as viewed from front to back of aircraft

Clear and convincing evidence shows the IGB had become loose in its mount on the tail pylon due to the material failure of most of the eight nuts and studs used to secure it to the aircraft. During the post mishap evaluation of the IGB, four of the eight nuts were missing. Of the remaining four, two were difficult to remove and two threaded off their studs normally, though the self-locking feature of the latter two nuts was not very effective.

Three of the eight IGB mounting studs were not visible; one was completely missing and two had broken in the nut threads. Two of the other five had pulled out of the center housing due to cracks where they were mounted to the housing. Of the remaining three, one did not have a nut, one had a nut with stripped threads, and one was intact with the nut found installed. Collectively, there were only two studs still attached to the center housing and with nuts on the threads, of which one was stripped (see Figure 2, Stud 6 and 7). Additionally, the counter-sunk screws, which attach the input housing to the center housing, were all stripped or broken. Some or all of these material failures occurred prior to landing and allowed the IGB gears to become intermittently loosely engaged or disengaged in flight at a cyclical rate. With as few as only one stud and nut properly secured (Stud 6), it is possible the IGB armor was the only real structural linkage keeping the IGB mounted to the tail pylon.

Following the mishap, a TCTO was issued 19 Oct 07 to inspect all MH-53s and adjust IGB torque values to that prescribed by Sikorsky drawings (Tab U-2.19-21 through 21). Additionally, a technical order revision was released on 19 Oct 07 to correct AFTO's for removal and replacement of the IGB and add the proper torque values on the mounting studs and hardware (Tab U-2.23-24).
